⑨ BUREAU OF SHIPS GROUP
TECHNICAL INSPECTION REPORT.

⑥ OPERATION CROSSROADS,
U.S.S. DENTUDA (SS335).

TEST BAKER U.S. ⑨

USS DENTUDA (SS335)

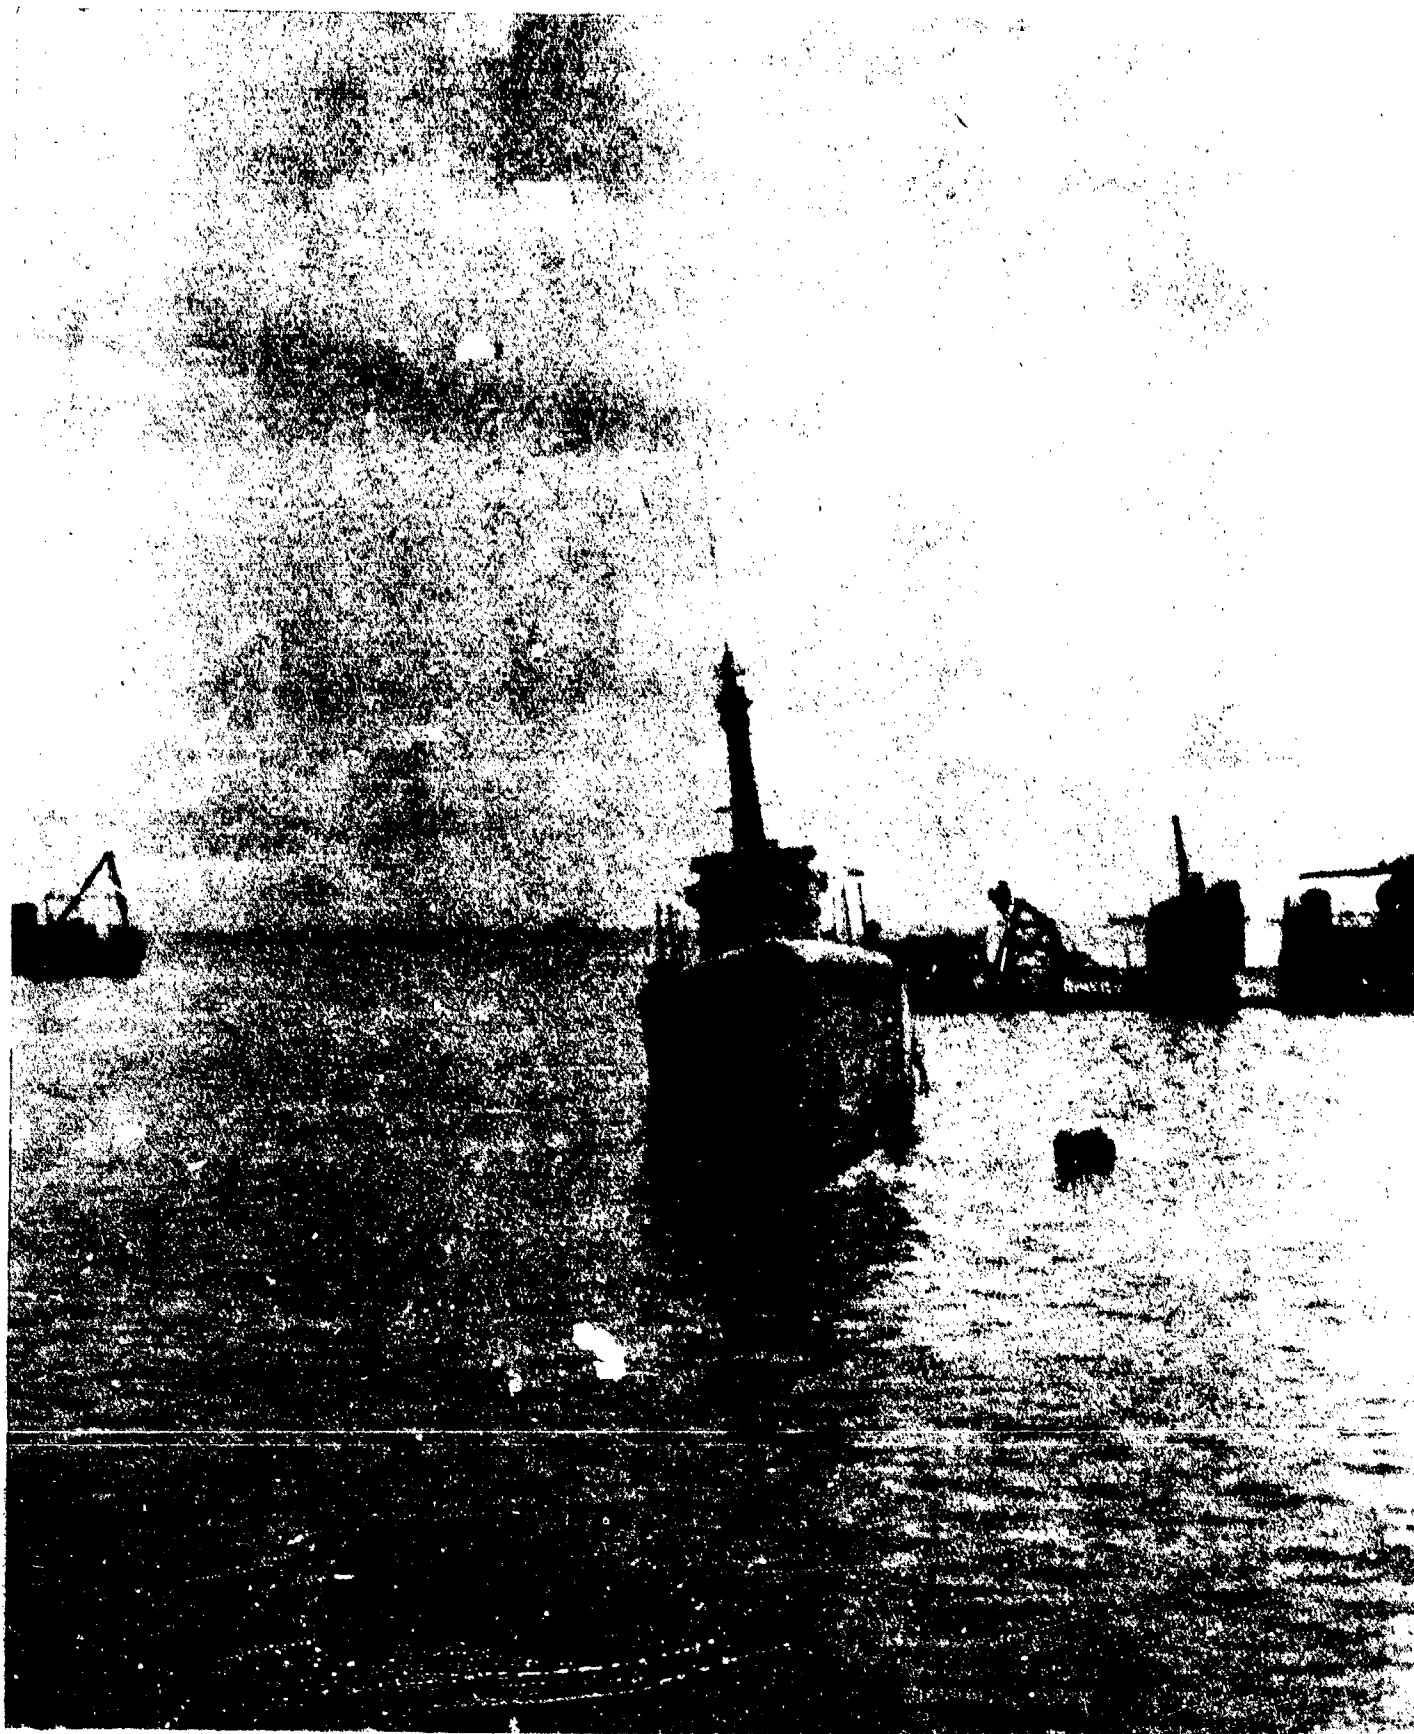
The DENTUDA received no major damage as a direct result of the Test B atom bomb. Had the ship been manned, the secondary damage resulting from flooding would not have occurred. For general views of the DENTUDA after the test, see photographs on pages 42 to 48.

AB-CR-227-290-27. General view from ahead - vessel beached.

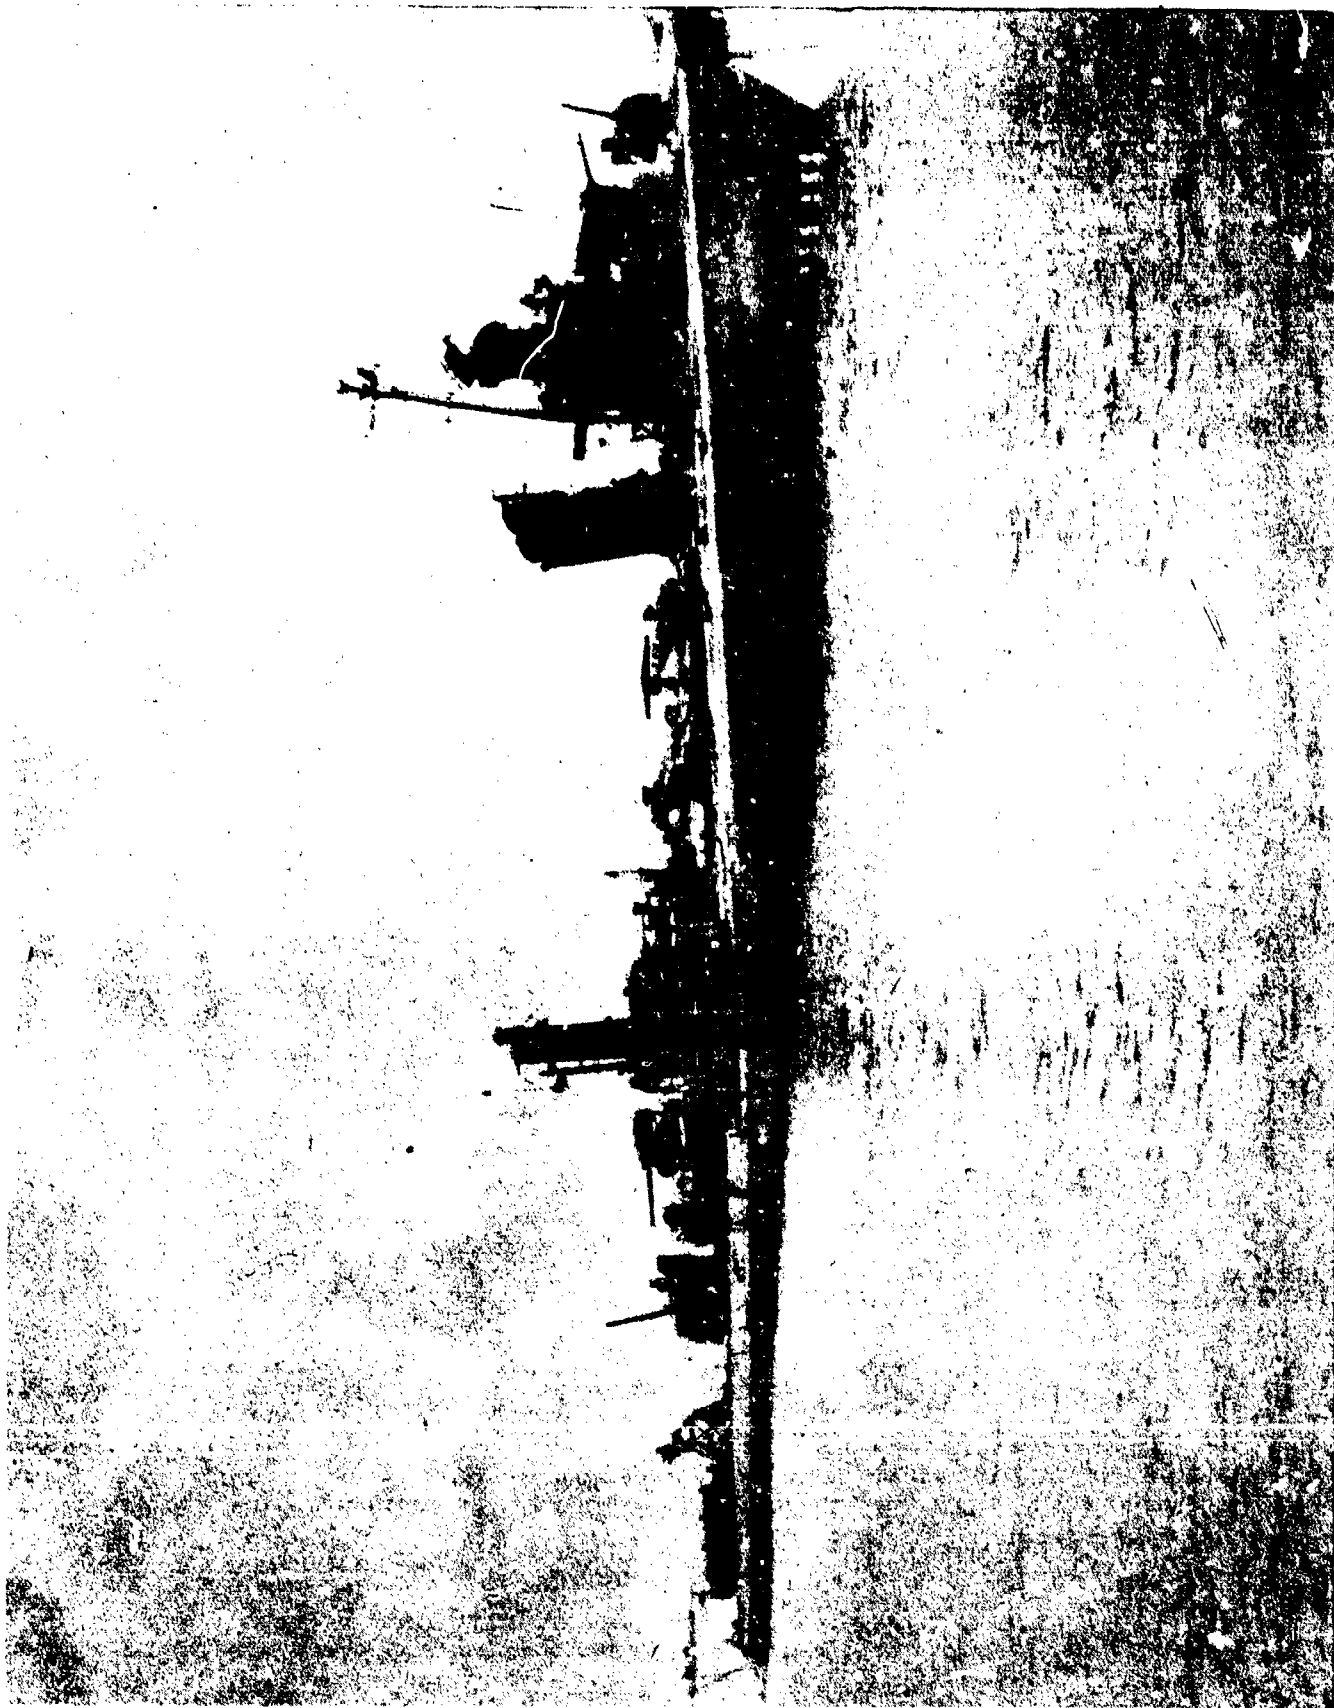
AB-CR-227-290-28. General view from starboard bow - vessel beached.

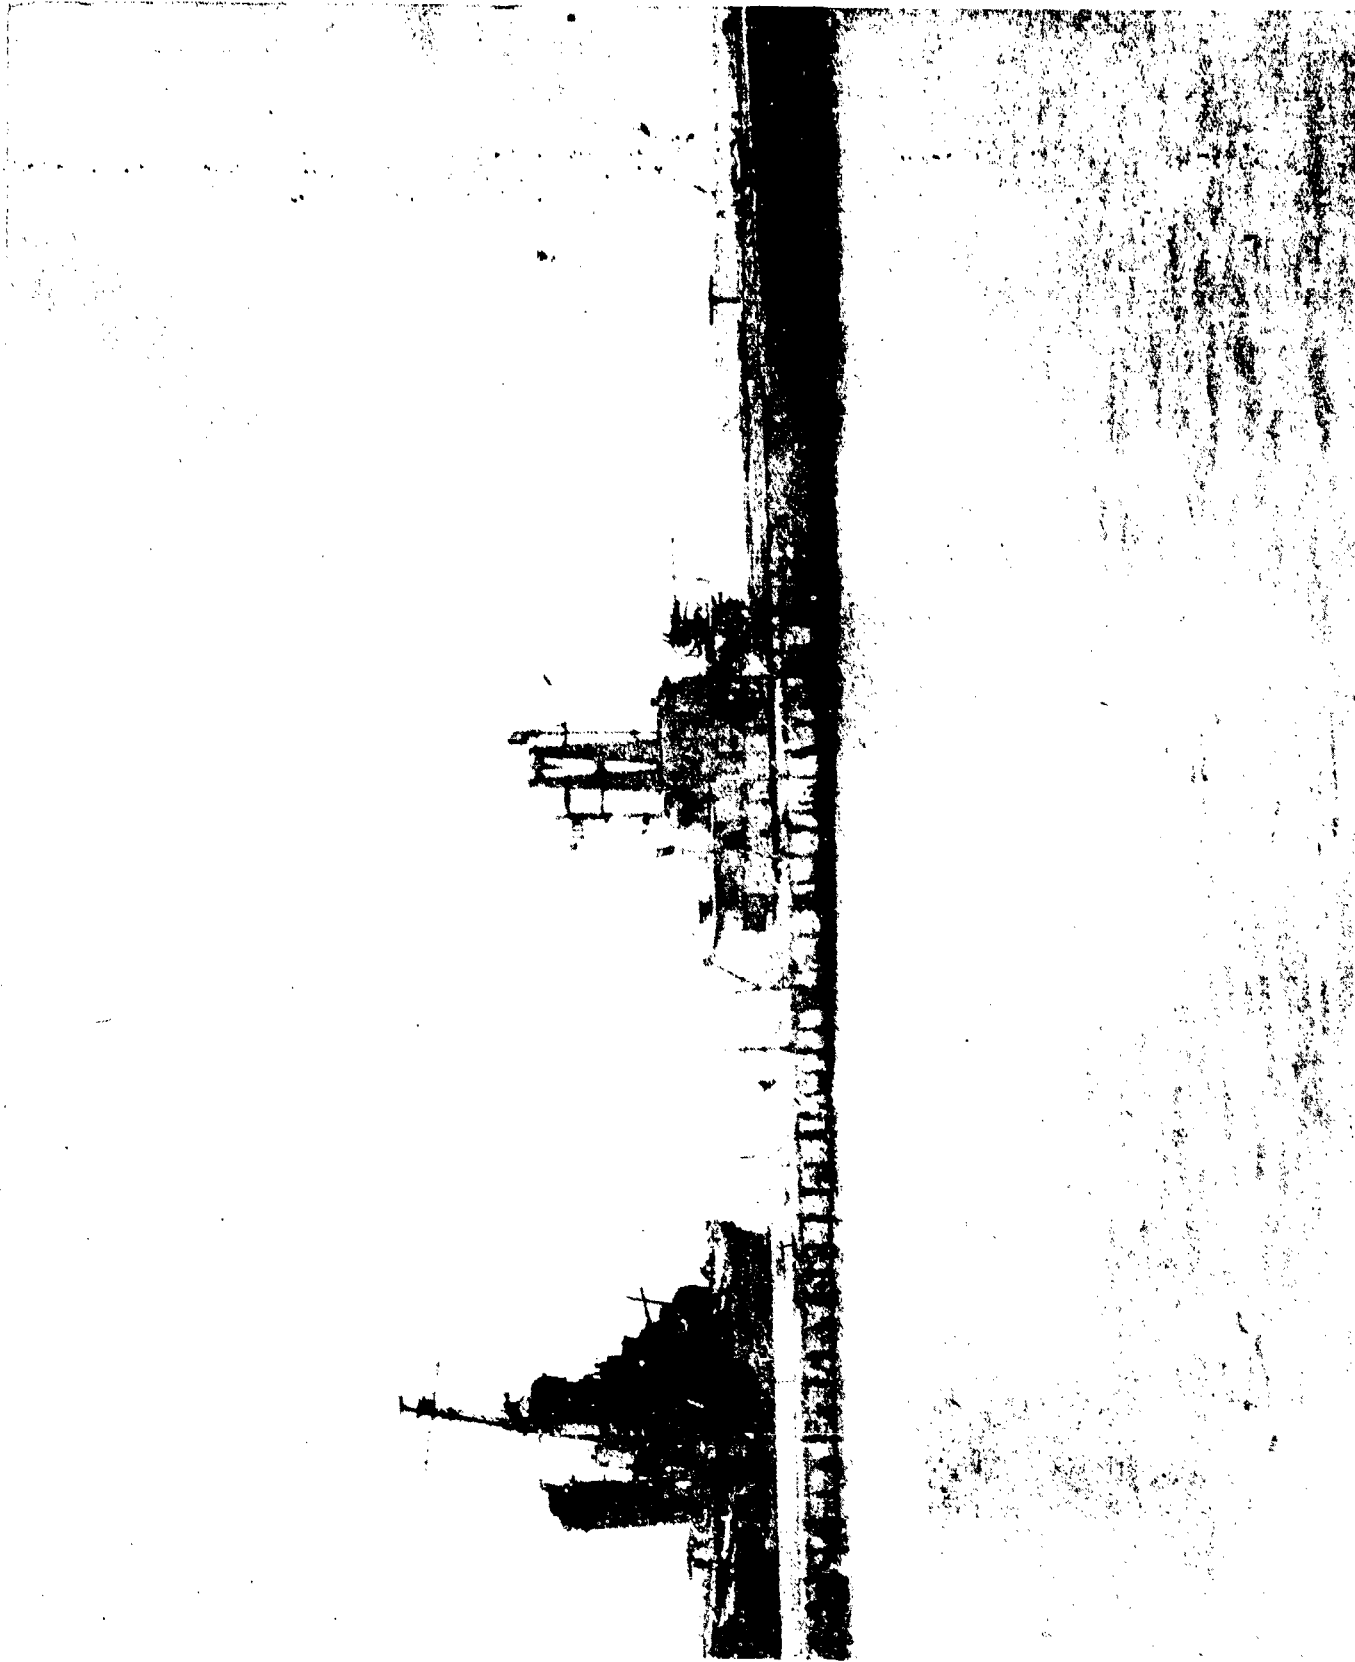
AB-CR-227-290-29. General view from starboard beam - vessel beached.

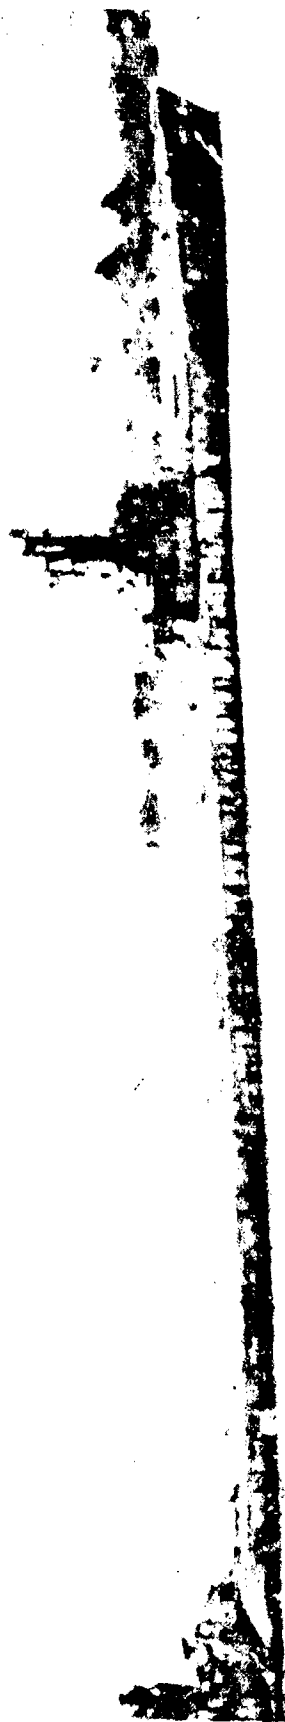
AB-CR-227-290-30. General view from starboard quarter - vessel beached.

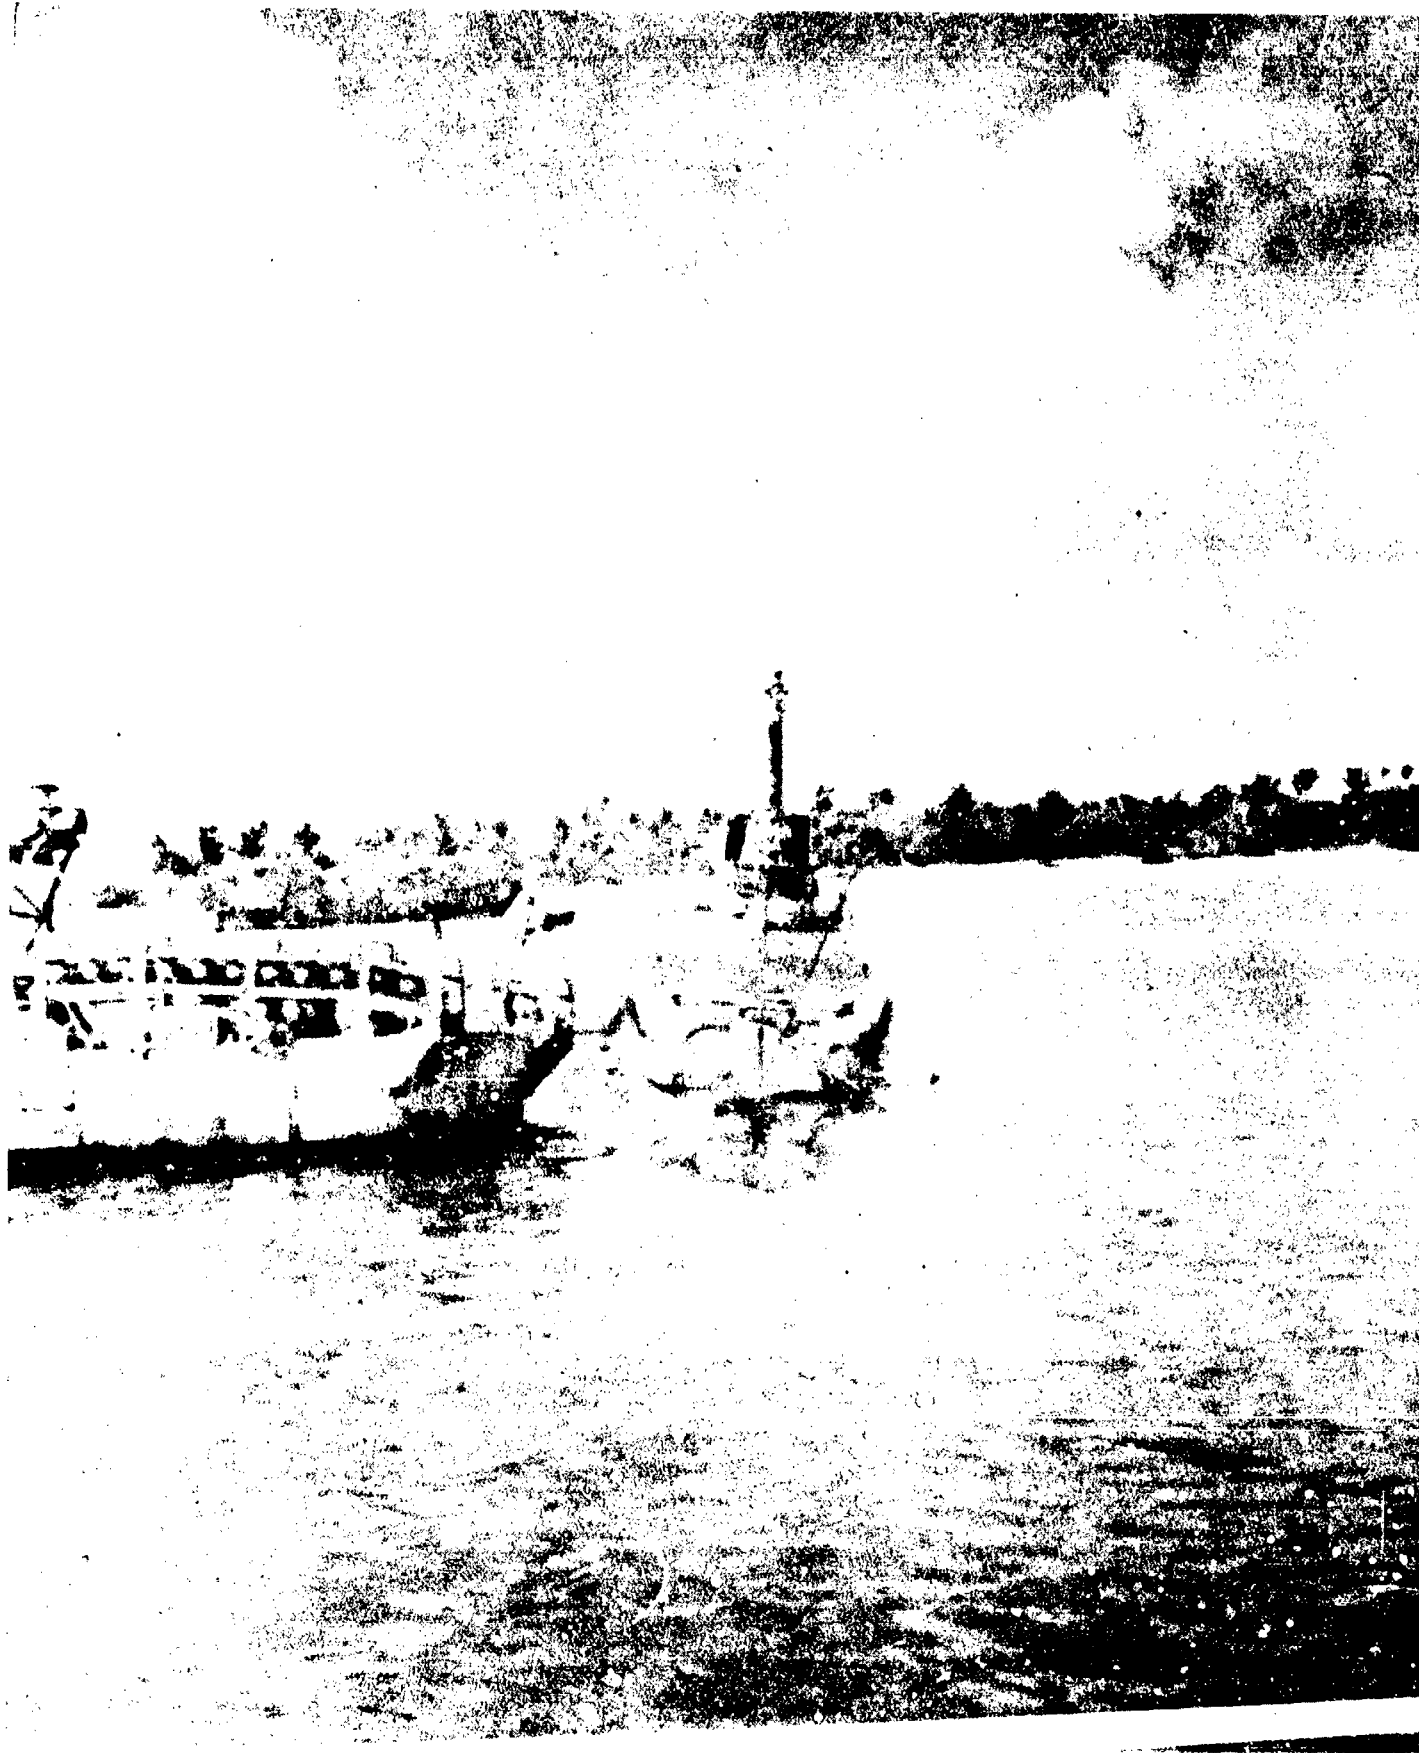
AB-CR-227-290-31. General view from astern - vessel beached.

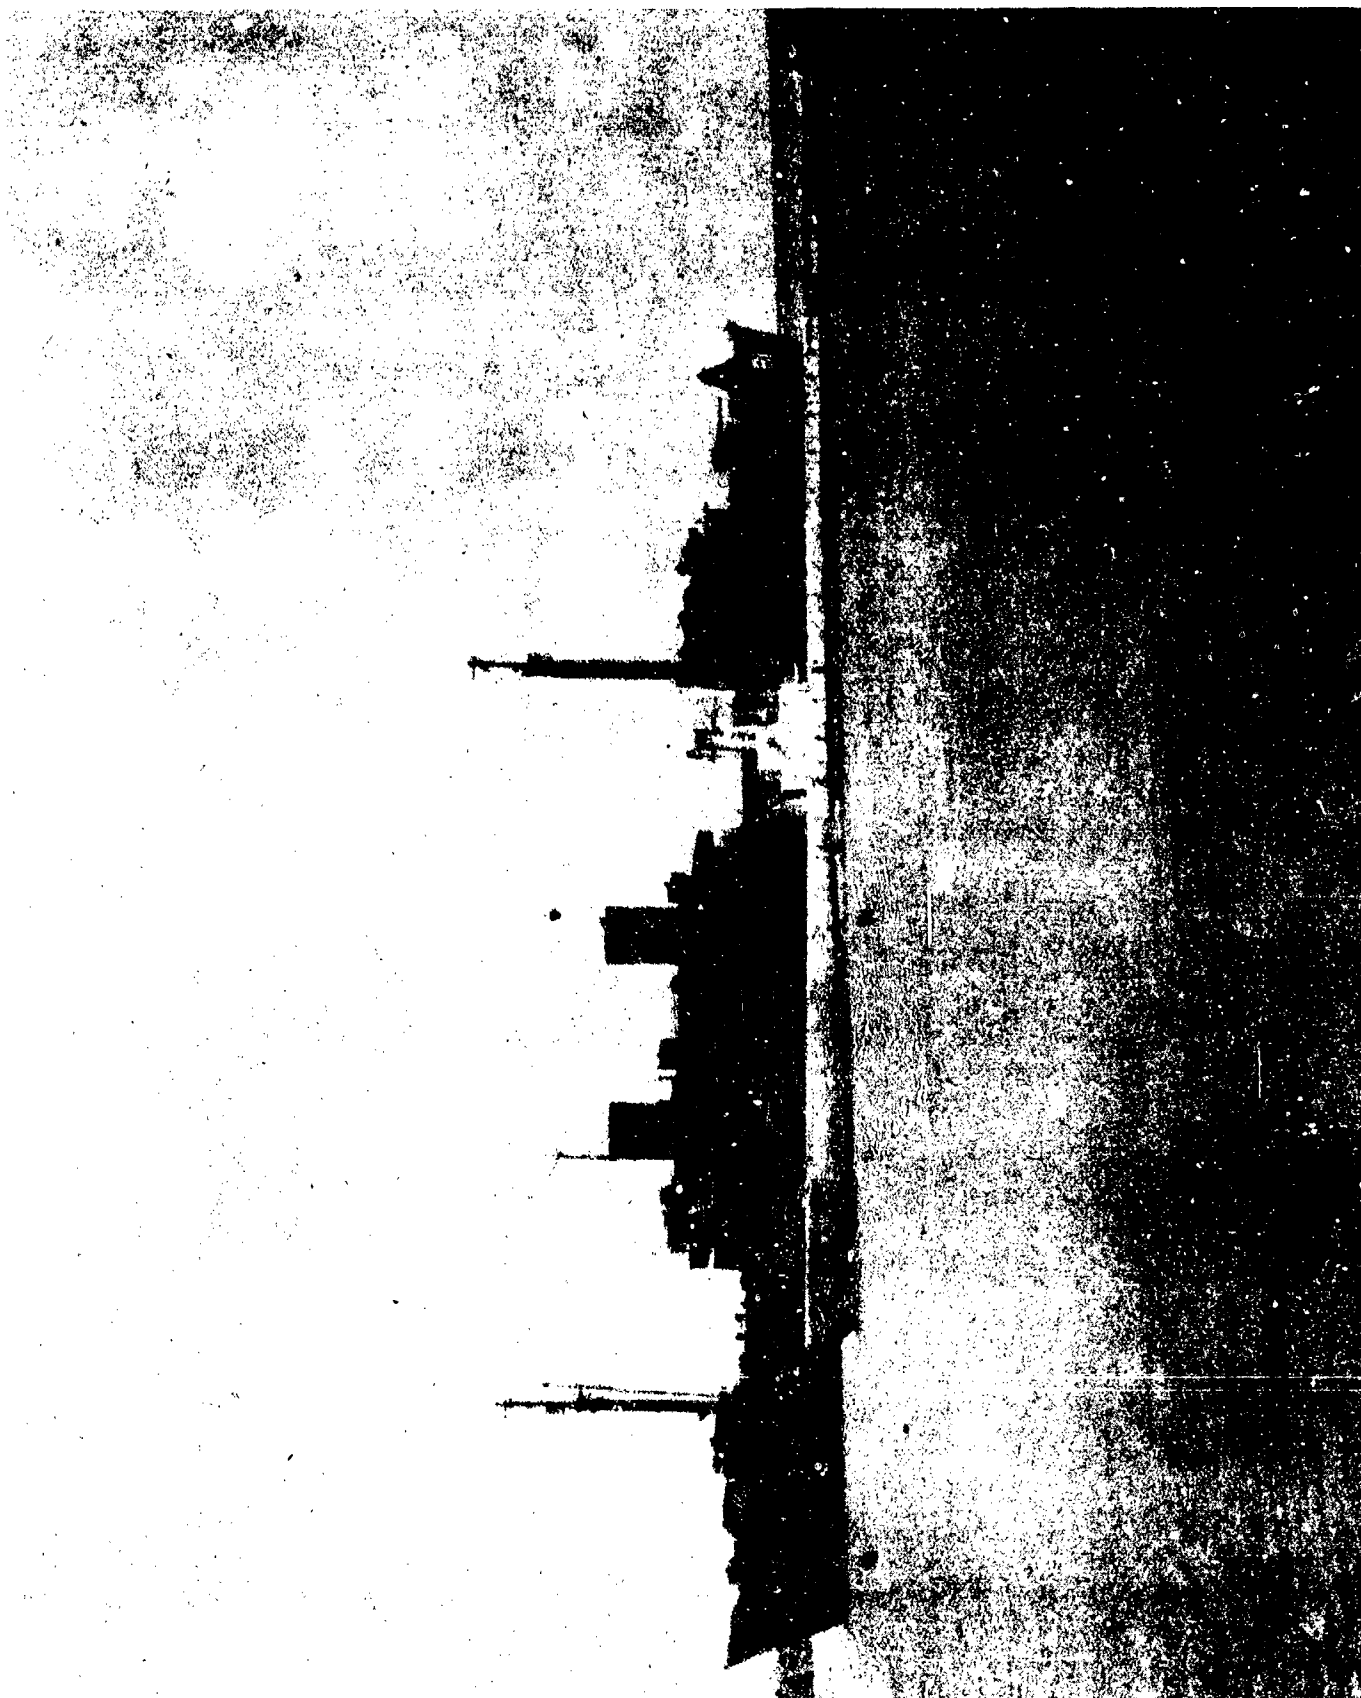
AB-CR-227-290-25. General view from port beam - vessel beached.

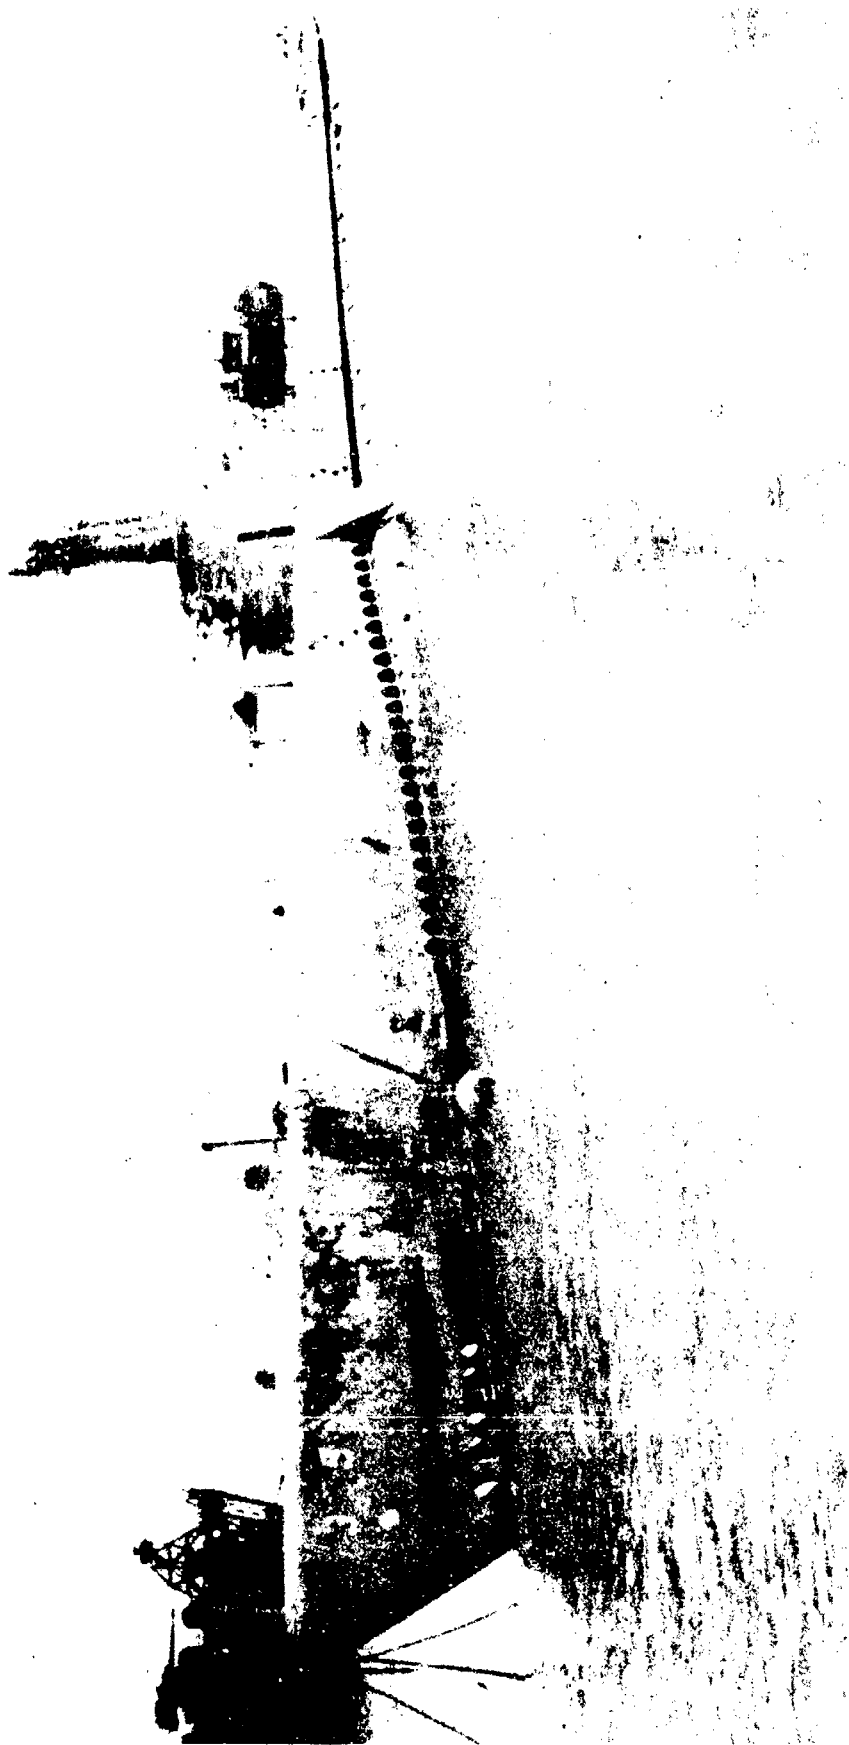
AB-CR-227-290-26. General view from port bow - vessel beached.
